SR 308 MP 2.16 Unnamed Tributary to Liberty Bay (991000): Preliminary Hydraulic Design Report

The proposed project will replace the existing 114-foot-long, 30-inch-diameter concrete culvert with a structure designed to accommodate a minimum hydraulic width of 20 feet. The proposed structure is designed to meet the requirements of the federal injunction using the confined bridge design criteria as described in the 2013 WDFW Water Crossing Design Guidelines (WCDG) (Barnard et al. 2013). This design also meets the requirements of the WSDOT Hydraulics Manual (WSDOT 2022a).

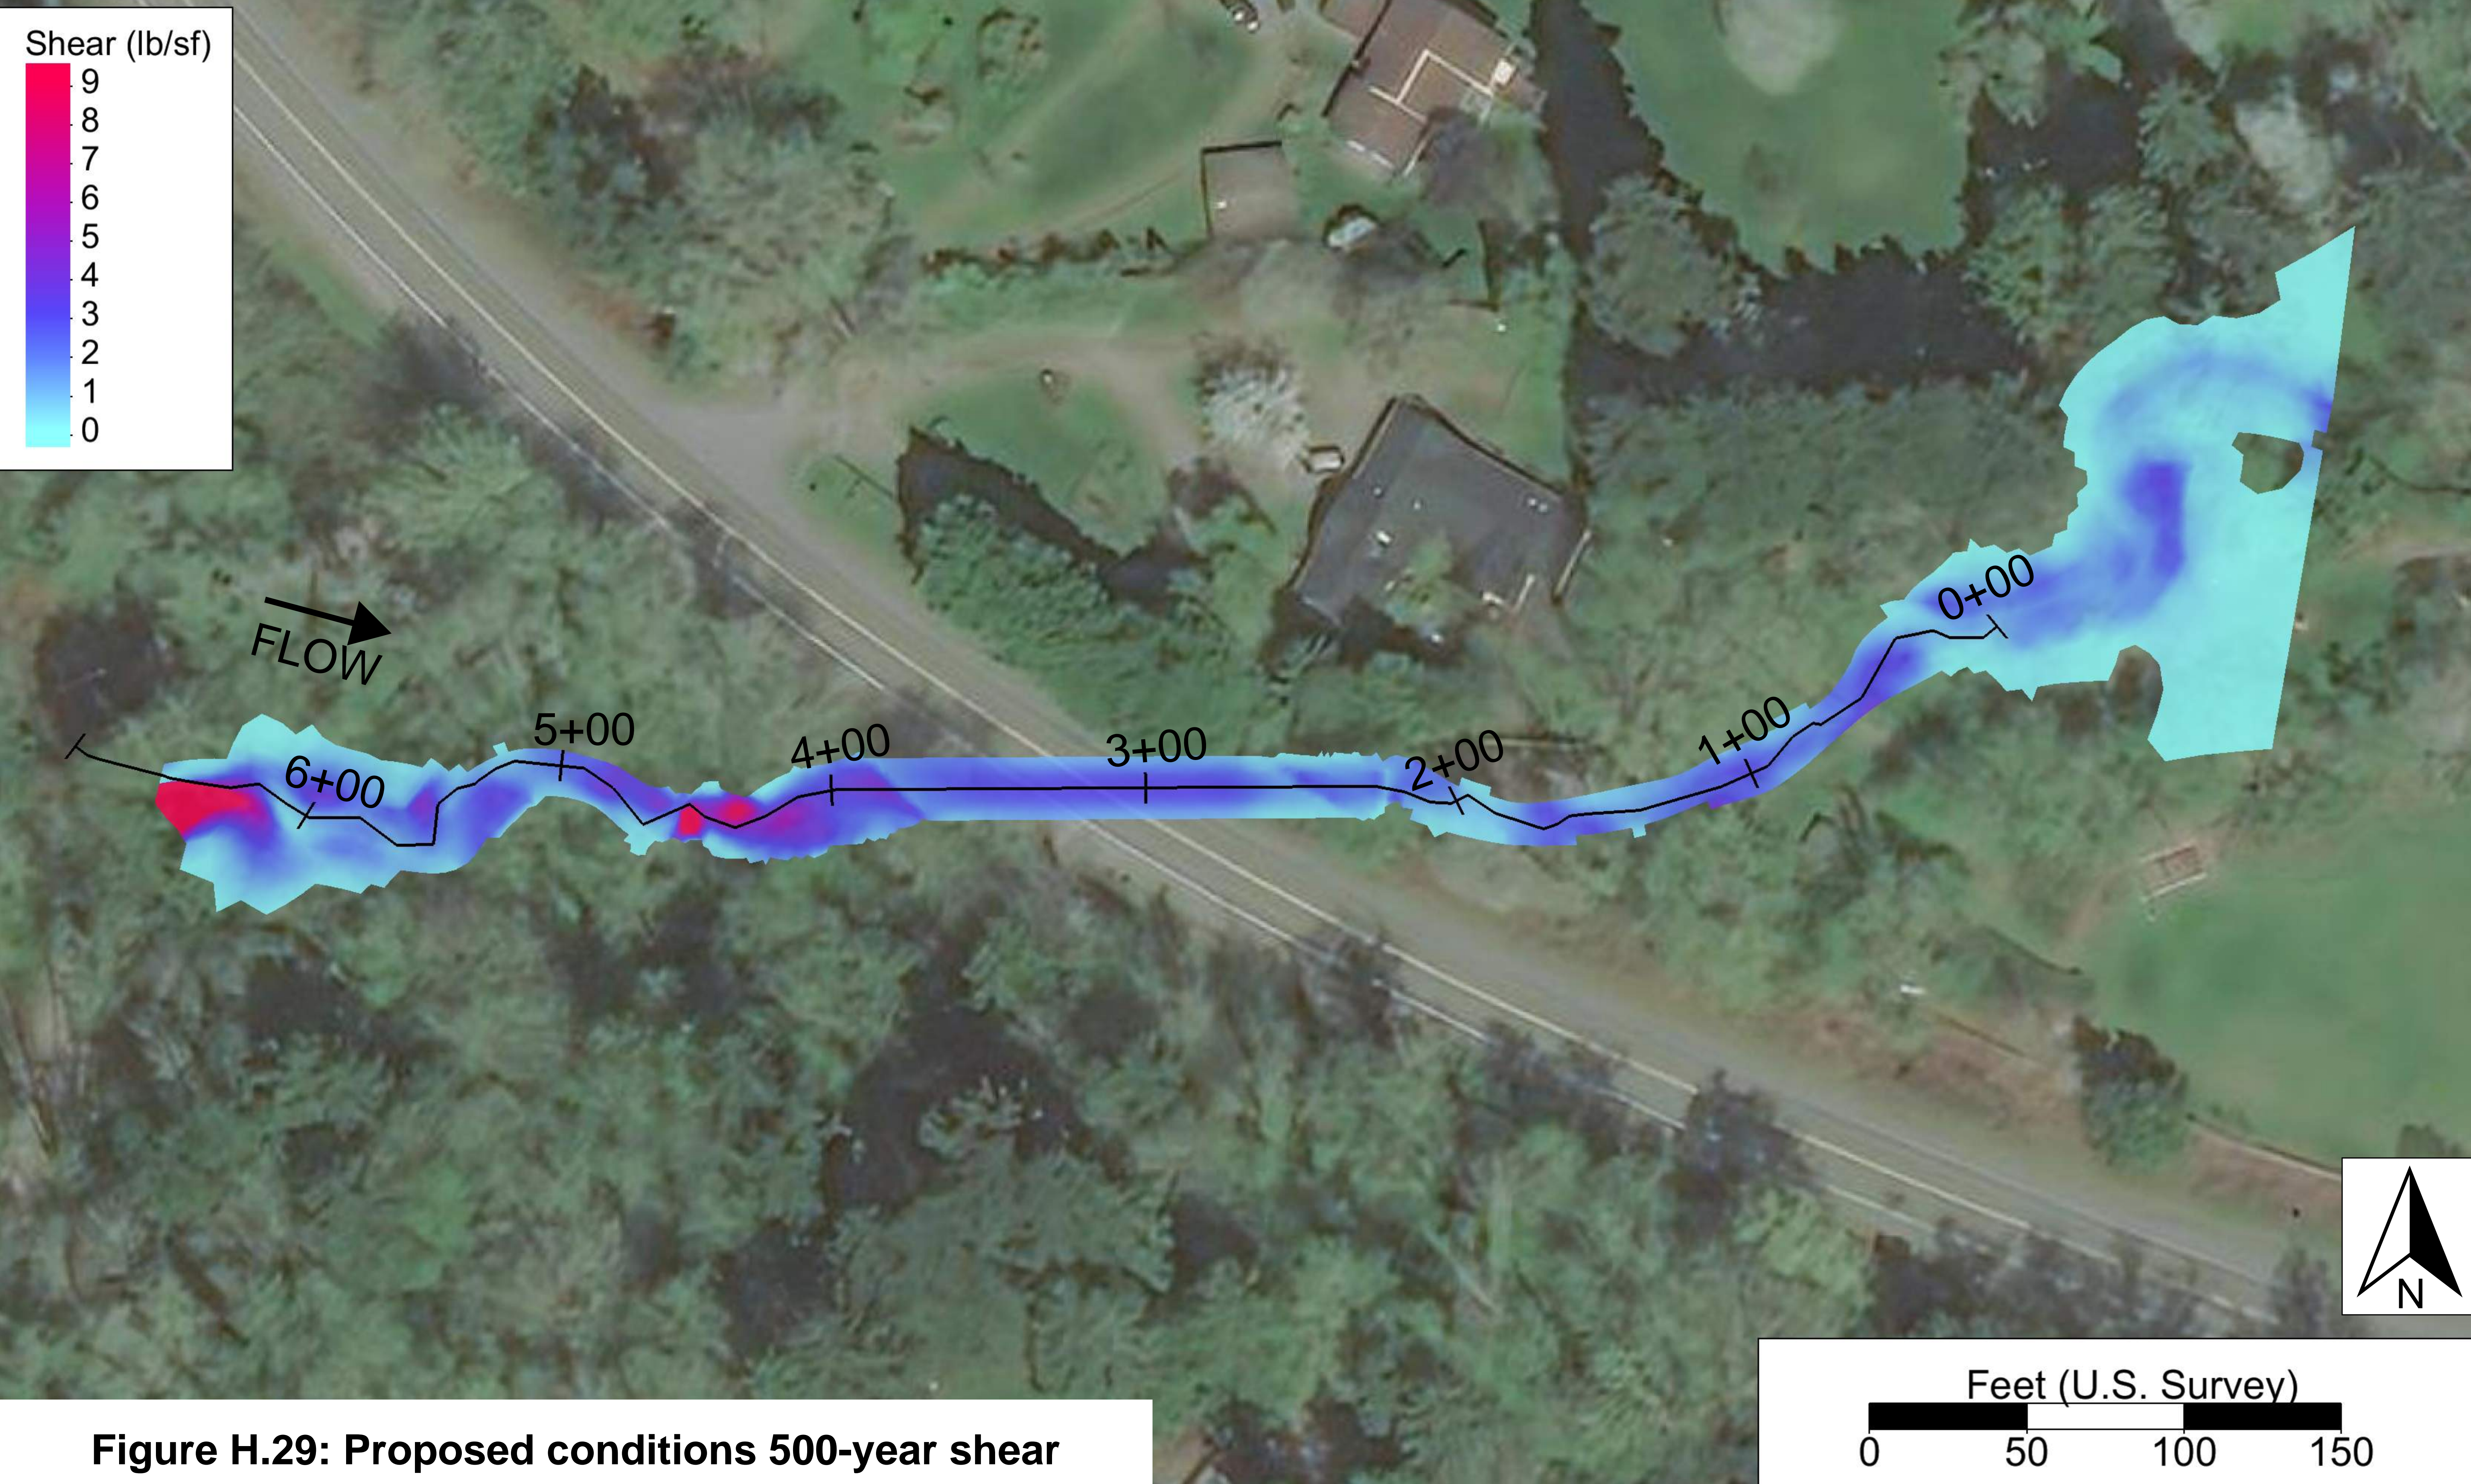
Figure H.29: Proposed conditions 500-year shear
